RE: Site Inspection, Georgia Pacific, Hebe Mine, M/015/072, Emery County, Utah

Date of Inspection: January 28, 2004
Time of Inspection: About 3:00 to 4:00 p.m.
Conditions: Clear, 20's, patchy snow about an inch deep
Participants: Paul Baker, DOGM

M/015/072, Hebe Mine, Georgia Pacific

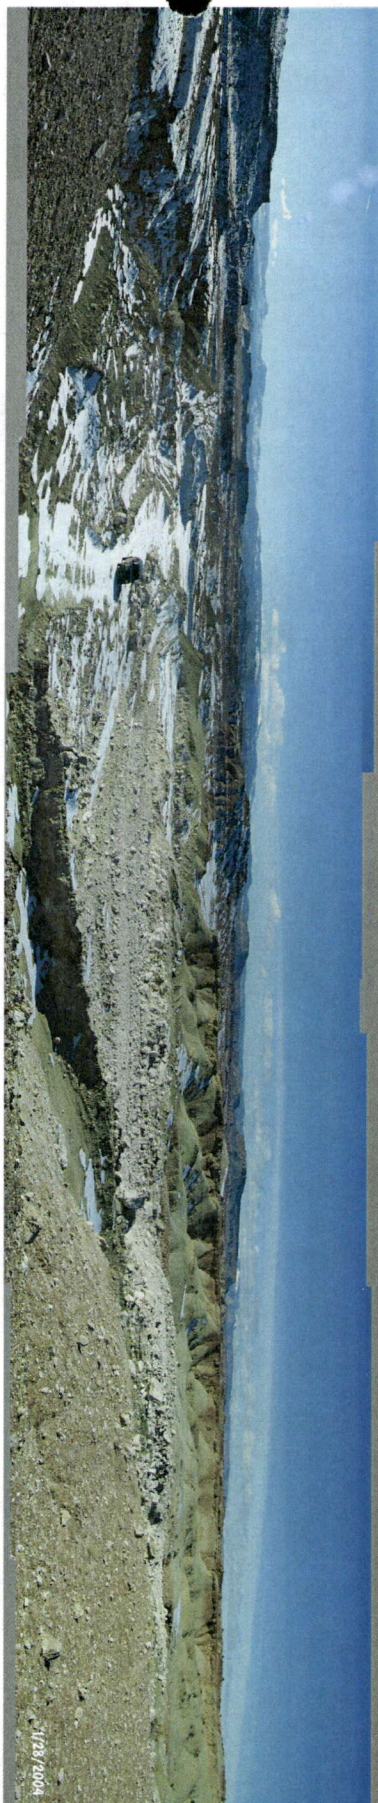
Within the disturbed area, there were some tracks, but there was otherwise no sign of recent activity. The site appeared unchanged since last May.

I took six photographs in a panorama of the site and stitched them together into Photo 1. This was done to document the current site conditions and to allow a future inspector to more easily tell if there has been any activity. I took other pictures of adjacent undisturbed areas, but I am not including them with this report.

Photo 1. Panorama of the disturbed area looking from the east.

The Division can release areas "D" and "E" from the permit area and from reclamation liability.
